TREATMENT OF EQUINE UROLITHIASIS WITH EXTRACORPOREAL SHOCK WAVE THERAPY (ESWT) - CASE REPORT

CASE

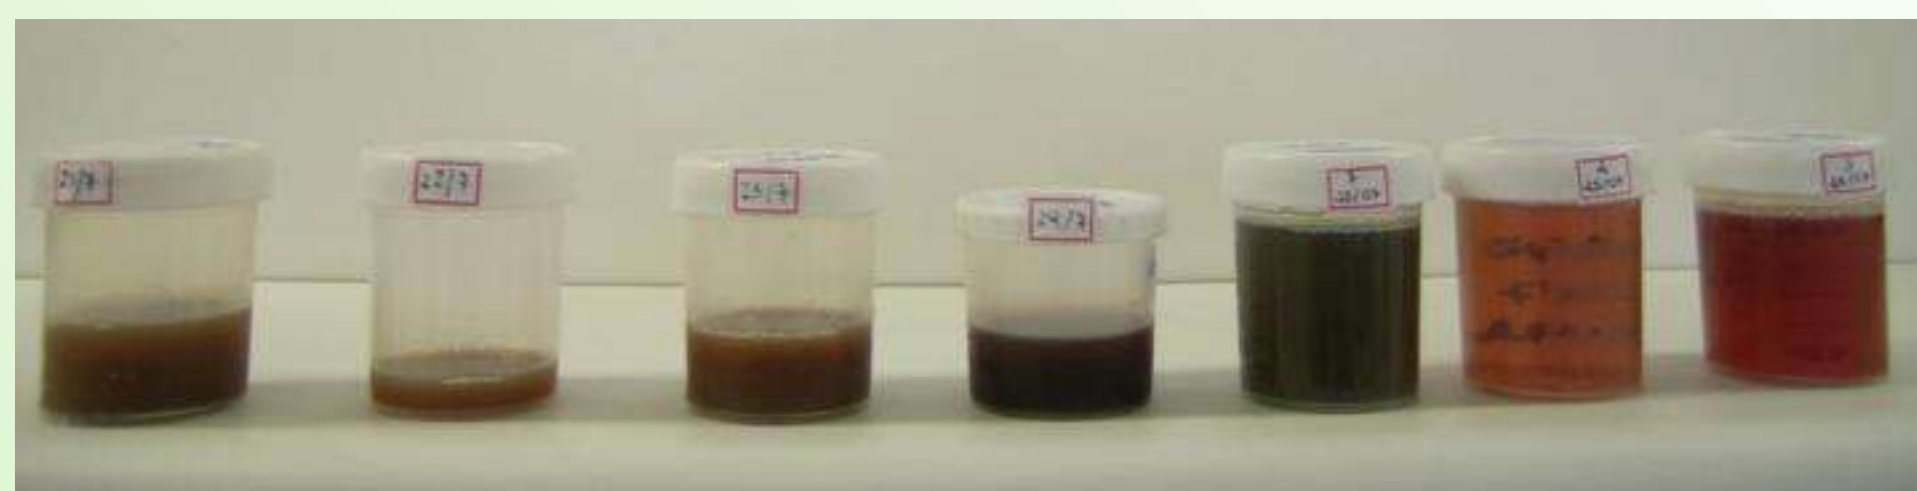
Fig.1. Urinalysis

The results of urinalysis(Fig.1), with animal at rest, showed pH = 5.0, bilirubin, erythrocytes, leukocytes, bacteria and crystals of mainly amorphous urate contents in large quantities. Were isolated *Staphylococcus sp*, *Klebsiella ozanae* and *Enterobacter sp*, sensitive to enrofloxacin.

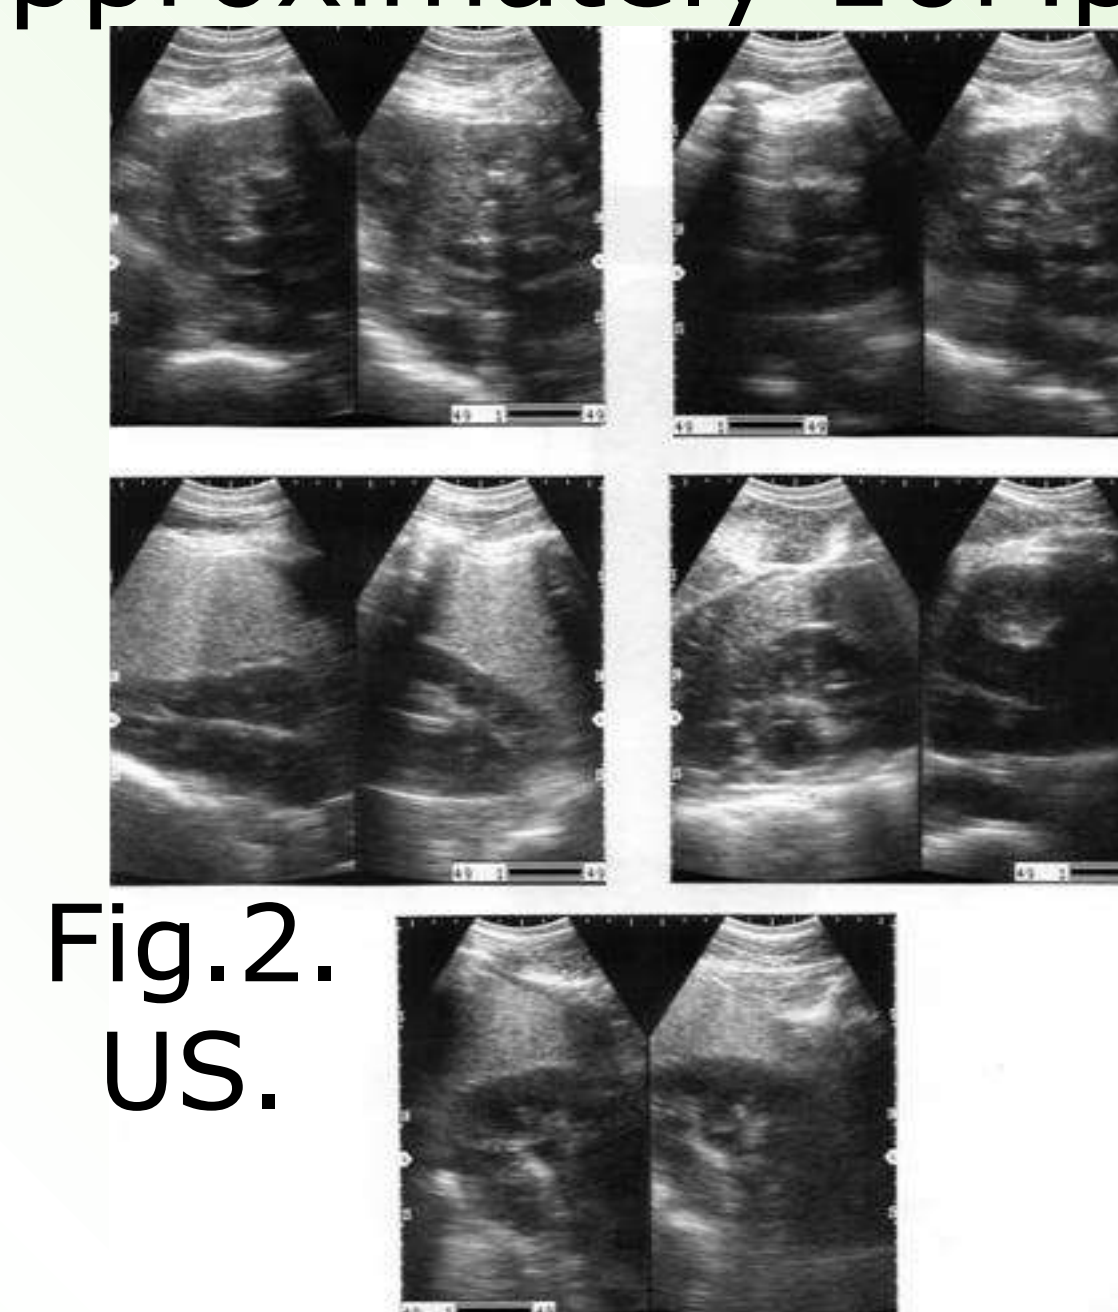
Fig.2. US.

The ultrasound examination (Fig.2) revealed a hyperechogenic line, approximately 5 mm, producing acoustic shadow in the hilar region of the right kidney (suggestive of kidney stone), bladder filled with anechoic fluid containing numerous heterogeneous formations of multiple forms (suggestive of blood clots). In urethroscopia, besides the presence of blood and clot, no changes were found throughout urethral tract and bladder.

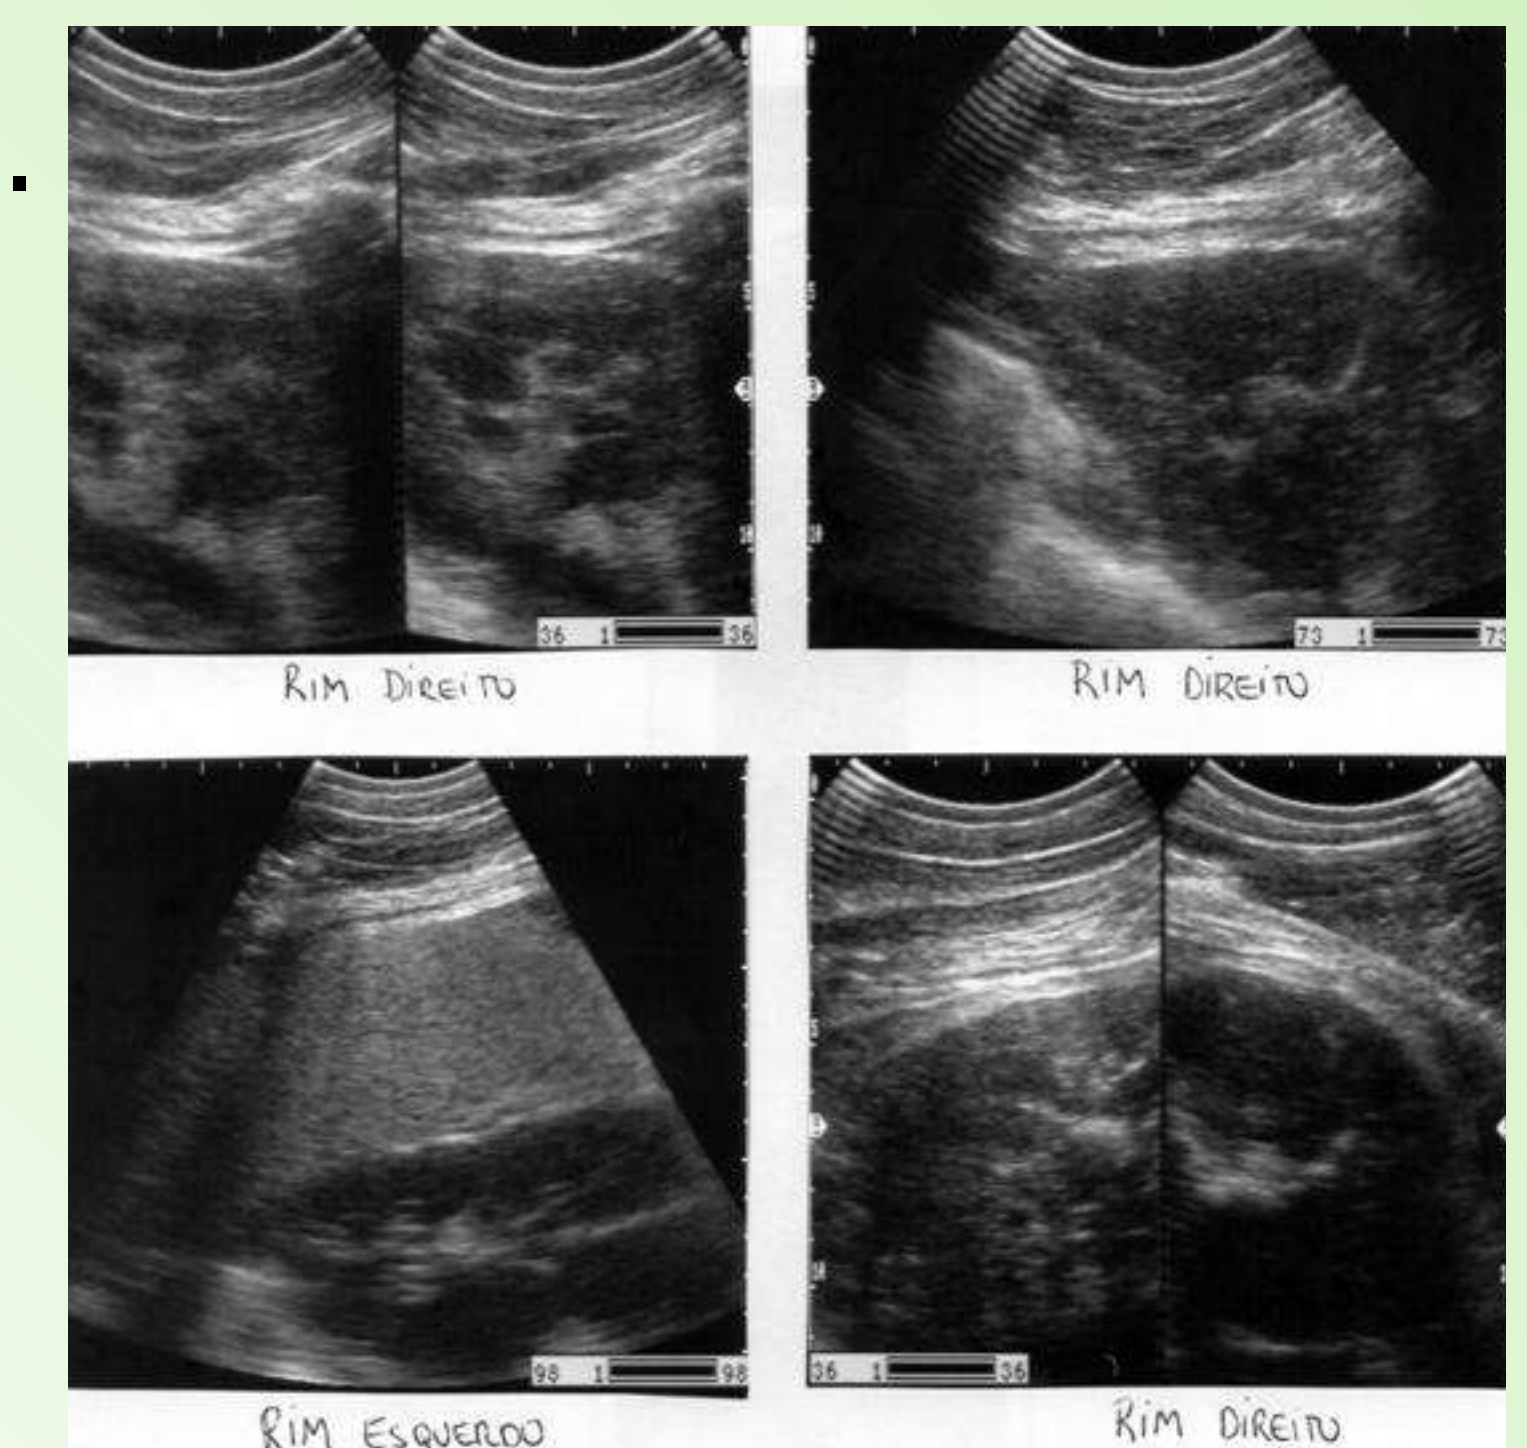
Fig.3. US.

One week after application of shock waves, the ultrasound examination (Fig.3) showed an increase in the thickness of the cortical and medullary layers, discrete heterogeneity in both the cortical and hypoechoic with loss of cortical medullary demarcation. Unable to identify the focus hyperechogenic in hilar region. A urinalysis showed pH = 8.5, clear amber color, low blood cell and peel.

One month after the shock wave therapy, the right kidney was normal ultrasound image. Residual fragments were not identified until now. The animal returned sports with excellent performance (Fig.4), without recurrence of hematuria (8 months). The use of ESWT is safe and useful alternative to the treatment of equine urolithiasis.
